## 41.2 Error in the 5Si/8000/8100

©2007 LIBERTY PARTS TEAM INC.

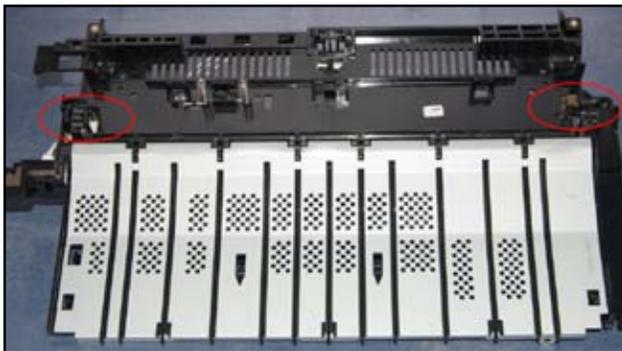
The last of these (bad connections to the transfer roller) is by far the most common. This is why you will often see the error (intermittently, accompanied by a half-printed page with a black line separating the printed half from the blank half) after installing a transfer roller or maintenance kit. There are two electrical connections to the transfer roller, one on each end, and both are easily damaged.

Fig. 1 Feeder Assy without transfer roller, connection points circled.

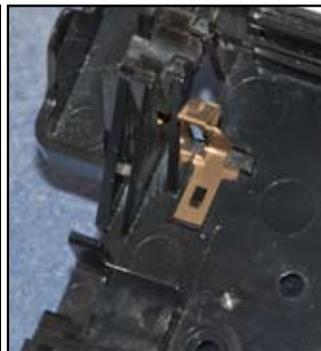
The left, or front, connector is a copper leaf spring that directly contacts the metal shaft of the transfer roller. We believe that this is just a ground path that discharges the roller after the high voltage is removed. If it were missing completely, you might never notice (our test bed seemed to print normally with this contact removed). But if it’s making a poor connection, it can arc and cause the 41.2 error (we have seen this happen!). Whenever you install a transfer roller, check to make sure that this leaf spring looks like Figure 2, and that it makes a solid connection to the metal shaft when the roller is installed. It can easily get bent or dislodged if you’re not careful. In most cases, you can just bend it back to its normal position. If it’s too badly mangled to do that, your options are to remove it completely (better to not have it there at all than to have a bad connection)

Fig. 2 Close-up of left (front) connection point.

or replace the entire feeder assembly (the leaf spring is not available separately).

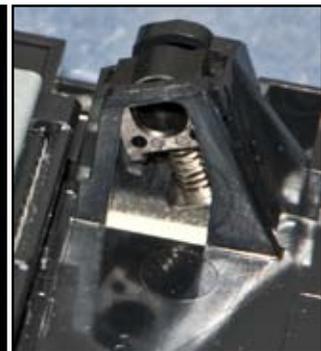
The right, or rear, connector is a coil spring that connects high voltage through the bushing (which must be at least somewhat conductive) to the right end of the transfer roller shaft. This is a more important connection – if it’s missing, you will definitely get a light, ugly-looking print. But, like the other one, if it’s poorly connected, it can arc and cause the 41.2 error. Each end of the spring fits around a plastic nub (one on the bottom of the bushing, and the other on the floor of the feeder assembly). As long as it’s on the nubs, you should have a good connection, but if either end comes off, you will have a problem. This shouldn’t happen unless the bushing has been removed, but it’s worth checking when you’re installing the roller, and especially if your printer has 41.2 errors or light print. If it’s not correctly positioned, you can remove the bushing (spread the plastic supports slightly and push up on the bushing) and reposition the spring. If either of these (bushing or spring) is missing or damaged, they are available individually.

Fig. 3 Close-up of right (rear) connection point.
