PRINTER REPAIR ARTICLE

HP CP6015, CM6030/40 “Internal Door 2 Open” Error

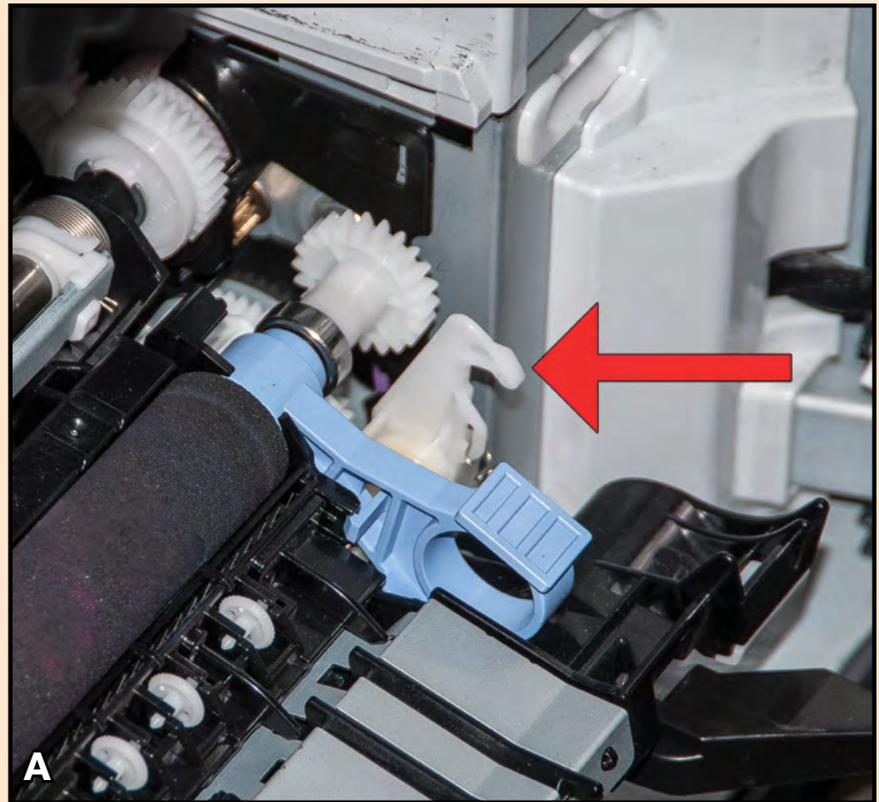
The “Internal Door 2 Open” error in these printer models occurs when the secondary transfer assembly does not latch properly, usually because one of the latching hooks is broken (Fig. A). The hook on the right side is more likely to break, because that is the drive side and gets much more stress. Either way, the solution is to replace the entire secondary transfer assembly (part number Q3931-67909), since the individual hooks are not available. Certain error codes (54.0E.03 on the CP6015, or 54.05.11 on the CM6030/6040) may also require replacement of this assembly. This article will show you how to remove and replace the secondary transfer assembly.

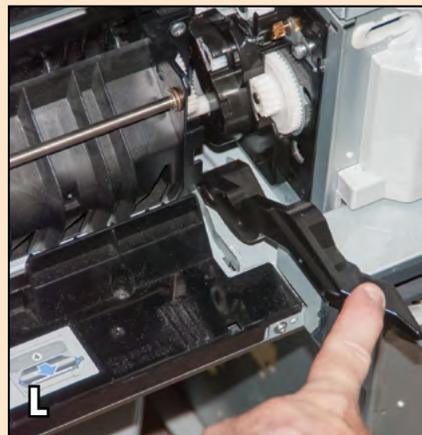
Holding down the stopper arm

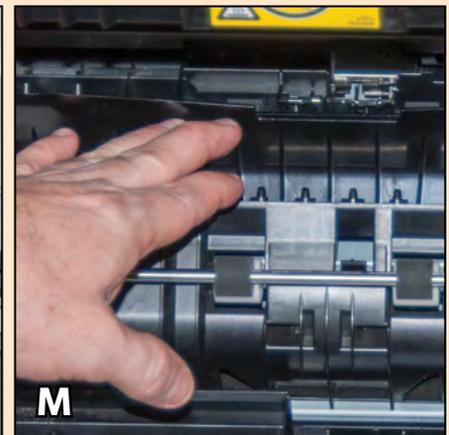
Holding the feed guide

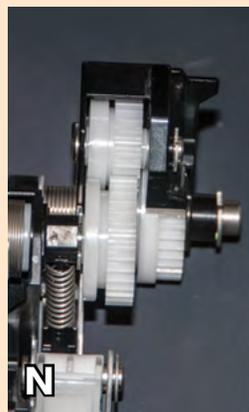
preparing the rear gear...

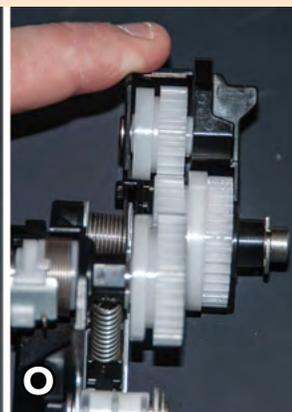
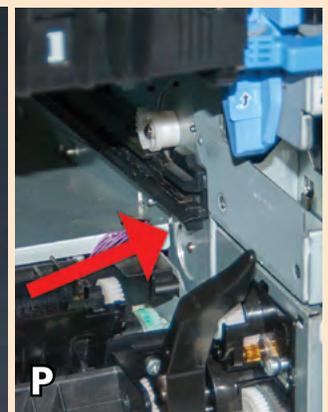
...to go beneath the ITB rail

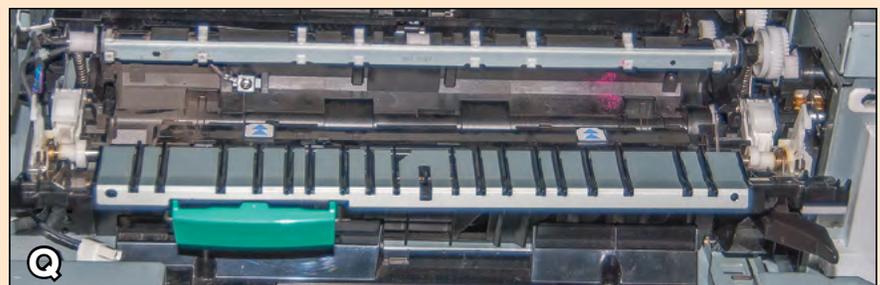
Installation complete.
