41.2 Error in the 5Si/8000/8100

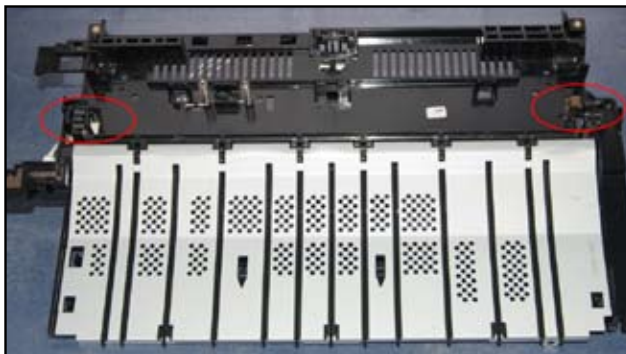
The last of these (bad connections to the transfer roller) is by far the most common. This is why you will often see the error (intermittently, accompanied by a half-printed page with a black line separating the printed half from the blank half) after installing a transfer roller or maintenance kit. There are two electrical connections to the transfer roller, one on each end, and both are easily damaged.

Fig. 1 Feeder Assy without transfer roller, connection points circled.

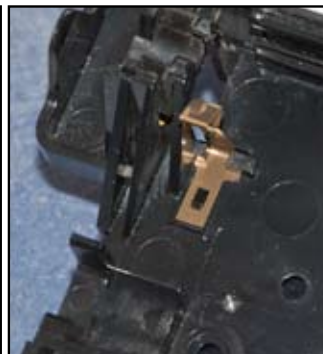
The left, or front, connector is a copper leaf spring that directly contacts the metal shaft of the transfer roller. We believe that this is just a ground path that discharges the roller after the high voltage is removed. If it were missing completely, you might never notice (our test bed seemed to print normally with this contact removed). But if it’s making a poor connection, it can arc and cause the 41.2 error (we have seen this happen!). Whenever you install a transfer roller, check to make sure that this leaf spring looks like Figure 2, and that it makes a solid connection to the metal shaft when the roller is installed. It can easily get bent or dislodged if you’re not careful. In most cases, you can just bend it back to its normal position. If it’s too badly mangled to do that, your options are to remove it completely (better to not have it there at all than to have a bad connection)

Fig. 2 Close-up of left (front) connection point.

or replace the entire feeder assembly (the leaf spring is not available separately).

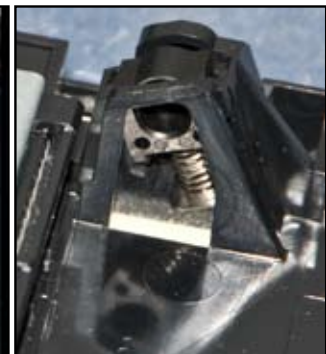
The right, or rear, connector is a coil spring that connects high voltage through the bushing (which must be at least somewhat conductive) to the right end of the transfer roller shaft. This is a more important connection – if it’s missing, you will definitely get a light, ugly-looking print. But, like the other one, if it’s poorly connected, it can arc and cause the 41.2 error. Each end of the spring fits around a plastic nub (one on the bottom of the bushing, and the other on the floor of the feeder assembly). As long as it’s on the nubs, you should have a good connection, but if either end comes off, you will have a problem. This shouldn’t happen unless the bushing has been removed, but it’s worth checking when you’re installing the roller, and especially if your printer has 41.2 errors or light print. If it’s not correctly positioned, you can remove the bushing (spread the plastic supports slightly and push up on the bushing) and reposition the spring. If either of these (bushing or spring) is missing or damaged, they are available individually.

Fig. 3 Close-up of right (rear) connection point.
