PRINTER TECH

CLJ 4600/4650: Blank Pages

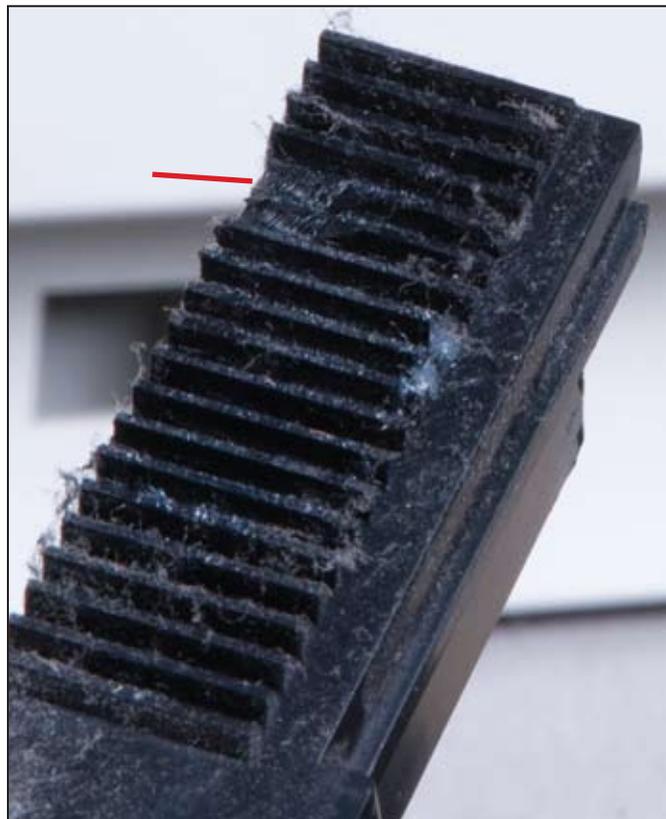
lems involving the toner cartridge drive and engagement systems, all located on the left side of the printer. The single most common problem involves the developer disengagement plate (Figs 11, 13), which is a plastic bar that moves up and down to tilt the toner cartridges, thereby engaging and disengaging the developer rollers inside the cartridges. The movement of the plate is controlled by gears, and what usually happens is that the gear teeth on the plate wear down or break. We will show you how to access the plate and what to look for.

10 Broken teeth on plate

2. Once you have removed the developer disengagement plate, inspect the two sets of gear teeth along the side (Fig. 10 shows an example of a plate with broken gear teeth). You may also want to look at the two gears in the printer (one at the bottom, one at the top) that couple to the plate, although usually these are OK. The lower gear is part of the developing disengaging drive asm, part number RG5-6507 (Fig. 12). The upper gear is available as a separate part (RS7-0139). The developer disengaging plate itself is RB2-8239 (Fig. 13). Replace any

of these parts that appear worn (usually just the plate), reassemble the printer, and blank pages should be a thing of the past!

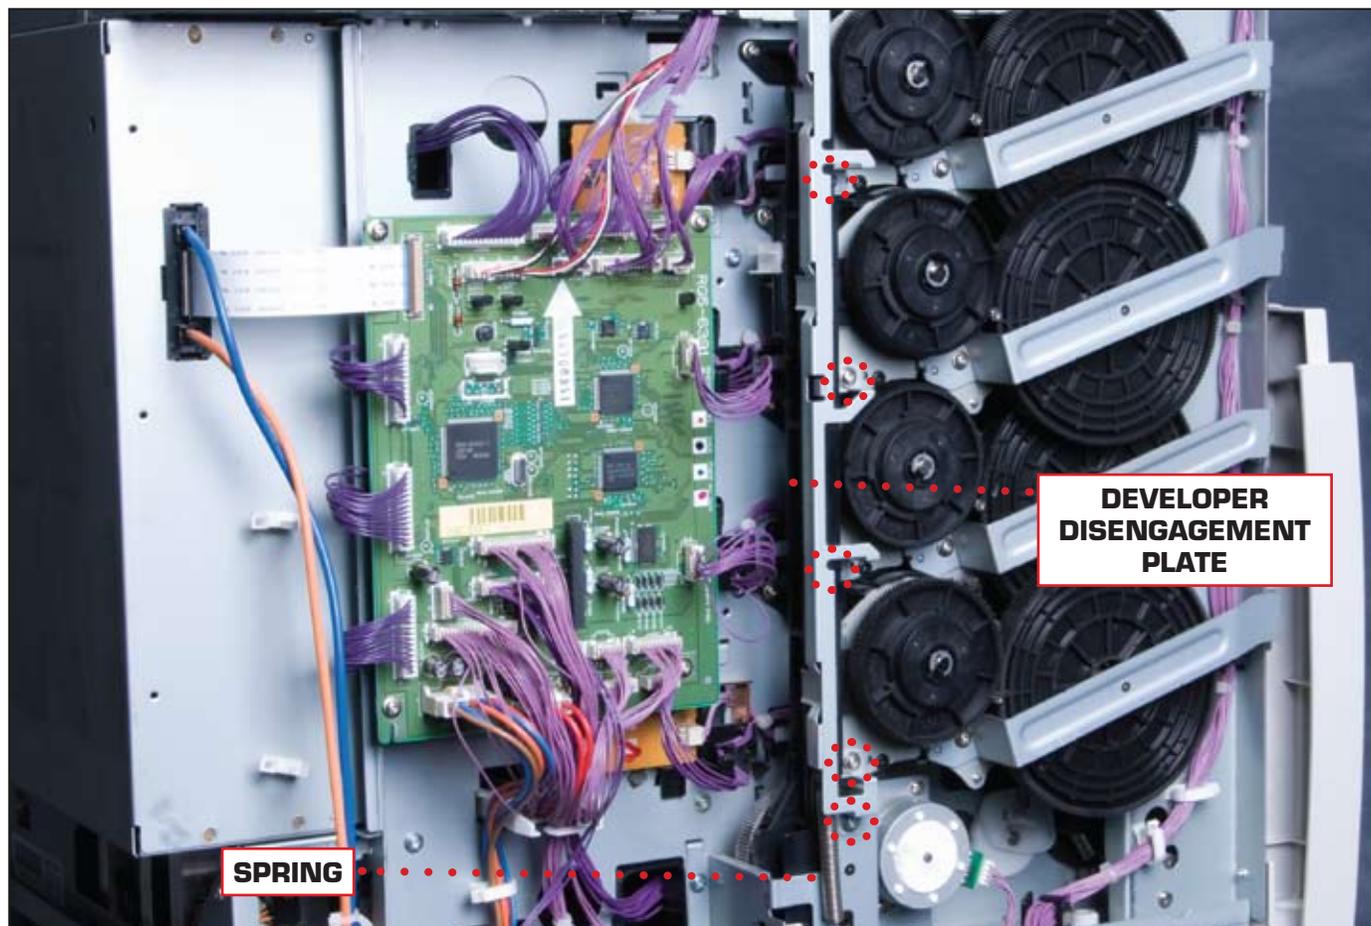
11 Replacing Developer Disengaging Drive Asm. Remove five CHROME COLORED SCREWS (NOT BLACK).

1. Remove the metal drum drive grounding plate that covers the plate (five screws – see Fig. 11). Then unhook the spring from the bottom and slide the plate up and out. There will be some resistance, since you will be turning the gears as you move the plate upward. You may have to use a screwdriver under the plate to lever it out, especially if it has broken teeth.
