The WAITING FOR TRAY TO LIFT error

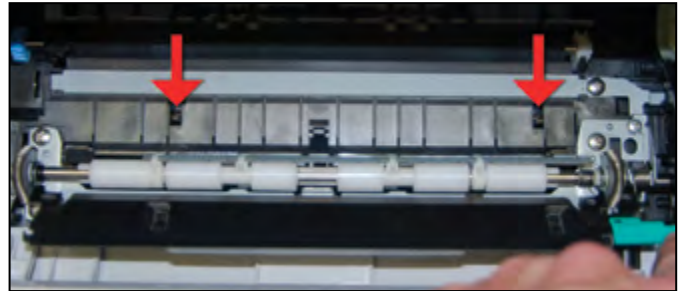
In the case of a broken left or right registration sensor flag in the 42xx/43xx family, something else happens. There are generally three sensors in the registration assembly: left, right and center. A failed central flag causes a 13 Paper Jam message. If either of the other two is broken or impeded, the control panel reads "Waiting for tray to lift," but the tray never lifts, and the "Ready" state is never reached. Note that a failed lifter mechanism would produce a 60.x error.

If the actuator flag is properly positioned and operational, you should be able to push it with your finger toward the back of the printer (i.e., in the di-

rection that paper would push it), and when you let it go, it should come back to the forward position. If it does not act this way, it's not positioned correctly. In almost all cases, all you have to do is reposition it.

Since the 4200 and some 4300 printers lack the sensor on the right, the original registration assembly lacks a hole for it. Installing this registration assembly in other models would impede the right sensor and cause the tray waiting error.

Check the left and right registration flags.
