## HP LaserJet 24xx Series: Gear Noise Solution

*This article shares a procedure omitted by the service manual for curing a gear noise problem in the HP LaserJet 2400 series. It will also help the printer tech avoid unnecessary fuser warranty claims.*

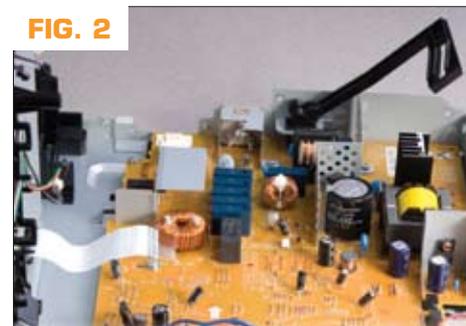
FIG. 2

CONTINUED FROM THE REVERSE  
the ECU, and the switch link holder installed in the printer chassis. Guide the link into the holder while installing the board. This will require some patience, but it seems to work better than the alternatives. Figs. 2 and 3 may help – Fig. 2 shows the link attached to the ECU board; Fig. 3 shows it installed in the link holder without the board.

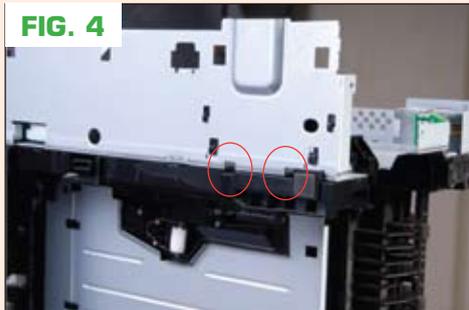
FIG. 4

1. The manual does not even mention the switch link. This is a black plastic arm or lever in the right rear of the printer; as its name implies, it links the external power switch with the internal switch on the ECU board. The upper end of the arm attaches to the ECU switch; the lower end slides into a plastic “link switch holder” that mounts into the right rear metal frame of the printer. You will want to carefully observe the orientation and alignment of the switch link while removing the ECU board, so that you can recreate it when re-assembling the printer. After removing the ECU board and switch link, also remove the switch link holder from the chassis (this will require releasing two retaining tabs, accessed from the bottom of the printer – see Fig. 4). There are several ways to re-assemble it, but we recommend starting with the switch link connected to

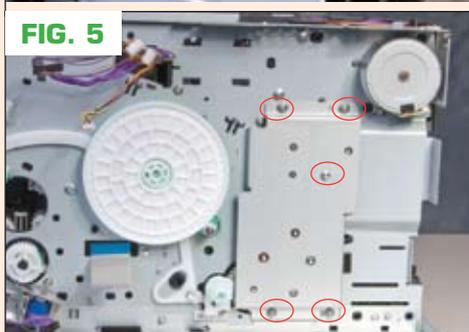
FIG. 5

Once the main drive assembly has been removed, it is a simple task to remove the fixing drive side plate assembly: remove the five screws shown in Fig. 5, and pull the assembly straight out. It will not come out if the three removable gears are still attached, so remove them first if you have not already done so. Once you have installed the new assembly, reverse the previous steps to re-assemble
