PRINTER TECH ARTICLE

Replacing 5000/5100 Fuser Drive Gears

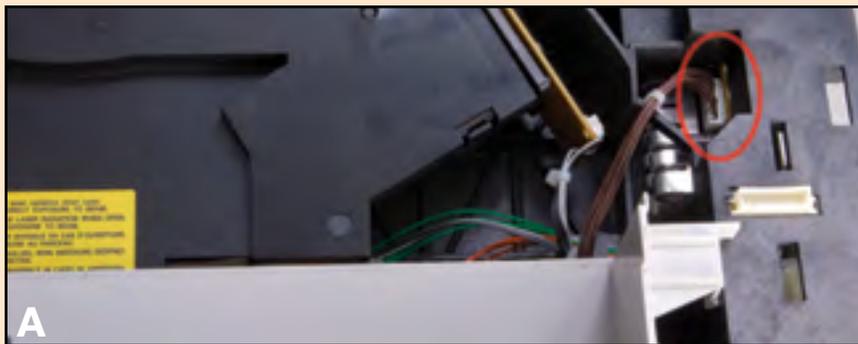
A

4. **Disconnect Main Motor Cable (Fig.A).**
5. **Remove the Main Drive Asm.**
 - a. Remove five self-tapping screws and one grounding screw (Fig. B); then rotate the bottom of the assembly out, away from the printer, and lower it to release the locating tab. Use caution to avoid breaking the toner cartridge engagement arm. At this point, you can replace the entire main drive assembly by simply reversing steps 1-5. If you wish to replace just the fuser drive gears, continue on to step 6.

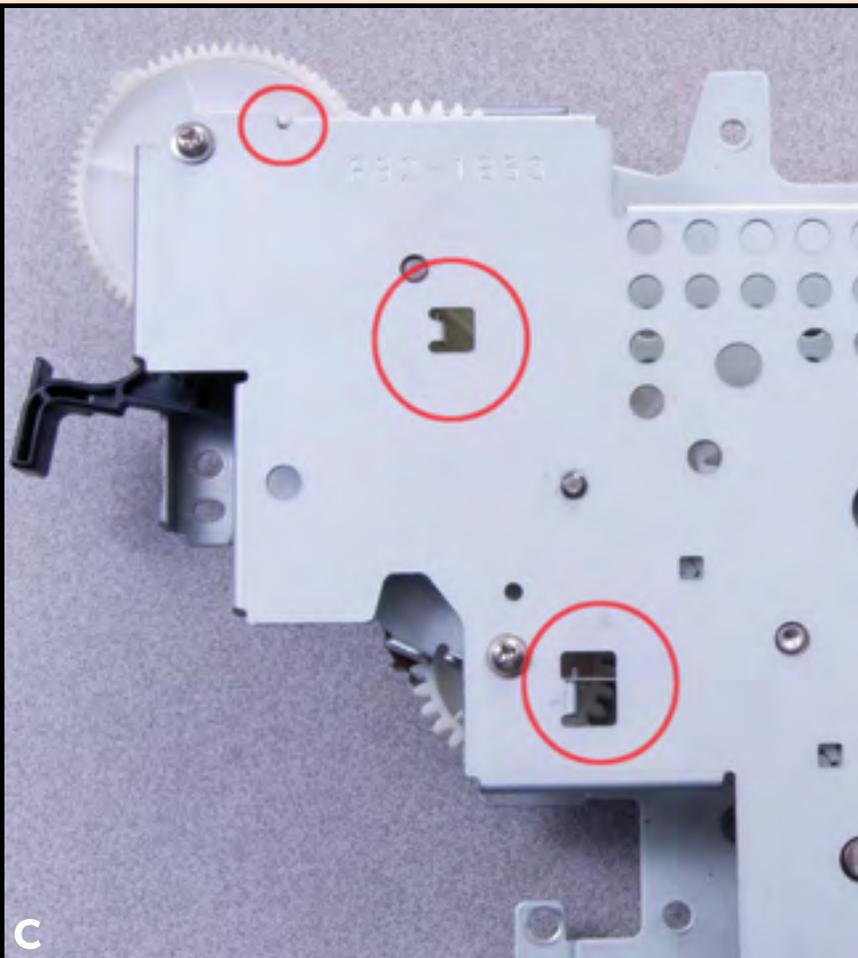
C

6. **Observe Orientation of Spring.**
 - a. Before disassembling the drive assembly to replace the gear(s), observe the orientation of the three torsion springs near the rear of the assembly (Fig. C). The tension on these springs will be released when the outer plate is removed, so you

will need to remember their correct orientation.

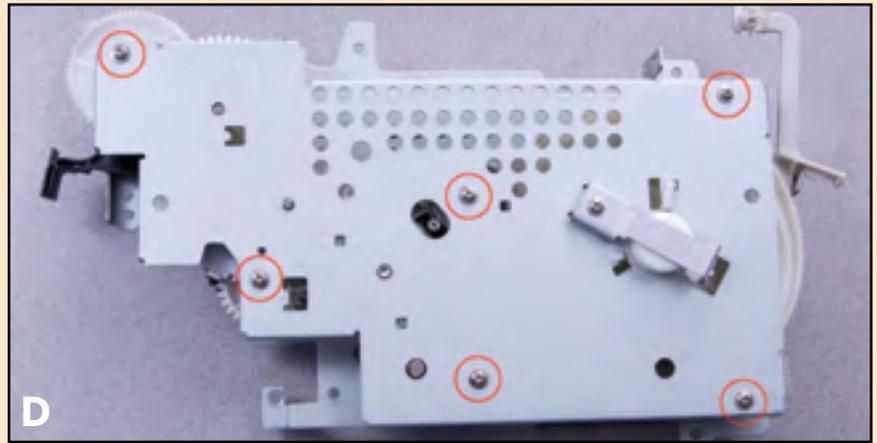
- Remove six screws (Fig. D) while maintaining pressure on the outer plate.
- The large toner drive gear seats into this plate, but is not secured by anything, so you will need to support this gear and hold it against the plate while disassembling (Fig. E). This is very important – the toner drive mechanism also contains the toner ground, and if it comes apart and is not properly re-assembled, the toner cartridge will not have a good ground connection, resulting in unsatisfactory print quality (Fig. F). The best policy is to make sure it does not come apart in the first place, by removing the outer plate and the toner drive mechanism together.

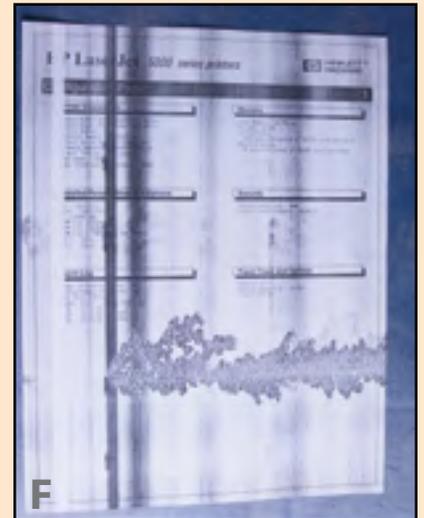
Do not forget to reconnect the toner cartridge engagement arm to the lid of the printer. Run a few test prints to make sure that everything has been re-installed correctly. In particular, make sure you do not get the kind of image shown in Fig. F (if you do, the toner cartridge is not getting a good ground connection).

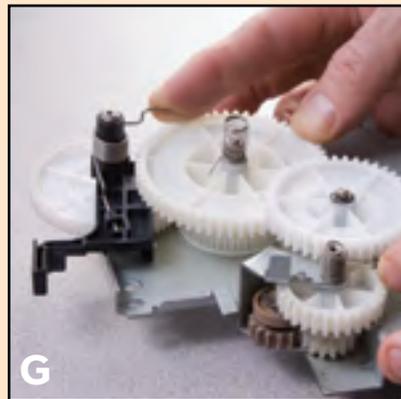
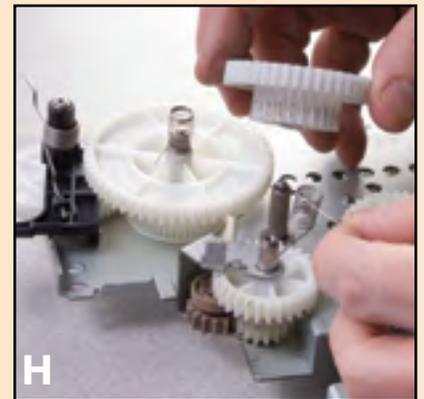
- Remove the 42/24-tooth double gear, then the torsion spring (Figs. G & H). Note the position and orientation of these items before removing them.

- Carefully reassemble the drive assembly, making sure to properly orient the three torsion springs (Fig. G shows these springs in the correct position, but without the outer plate). Then reverse steps 1-5 above to reassemble the printer.

- Now you can remove the swing arm/gear (this is the brown gear in the metal bracket) and the 29/14-tooth double gear. These gears will come off together. Note their relative position and orientation before pulling them apart (see Figs. I & J). When installing the new gears, make sure that the metal swing arm bracket is positioned on the correct side of the metal tab on the backing plate (the correct position can be seen in Figs. G & H).
