PRINTER TECH ARTICLE

Curing the 50.7 error in the LJ CP6015 & CM6030/CM6040

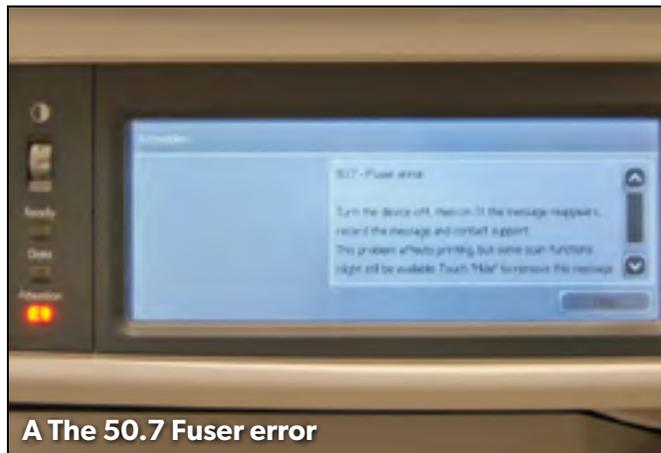
A The 50.7 Fuser error

Like many HP printer models, the CP6015 and its multi-function variants, the CM6030 and CM6040, can experience worn gears in the fuser drive. This has been resulting in 50.7 errors (Fig. A). If you see this error, call your Liberty Parts Team account executive and order RM1-3247, the one-way gear asm.

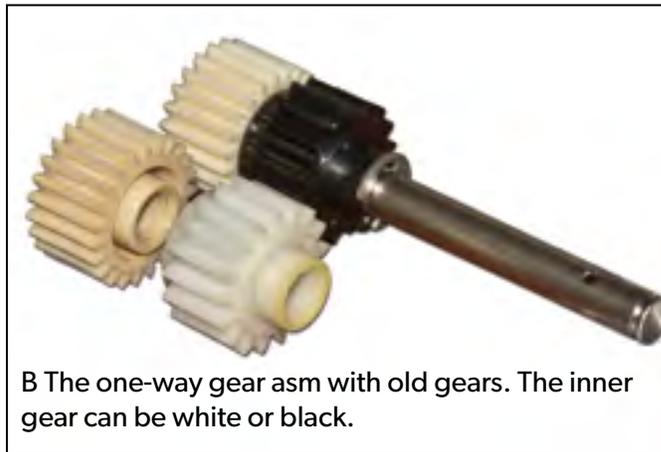
The fuser drive system in these printers is simple: a motor and two gears on the outside of the printer wall, and a one-way gear assembly in the fuser cavity. The one-way gear assembly is basically a shaft with two gears on it. Fig. B shows the assembly, and also the two gears removed from the assembly. Note that the inner gear, the one-way gear, may be either black or white.

B The one-way gear asm with old gears. The inner gear can be white or black.

3. REMOVE GEARS FROM NEW ASSEMBLY. Remove the gears from the new assembly the same way, install them onto the shaft in the printer, and replace the e-ring. Fig. B shows the proper orientation. Reverse the steps and you are done.

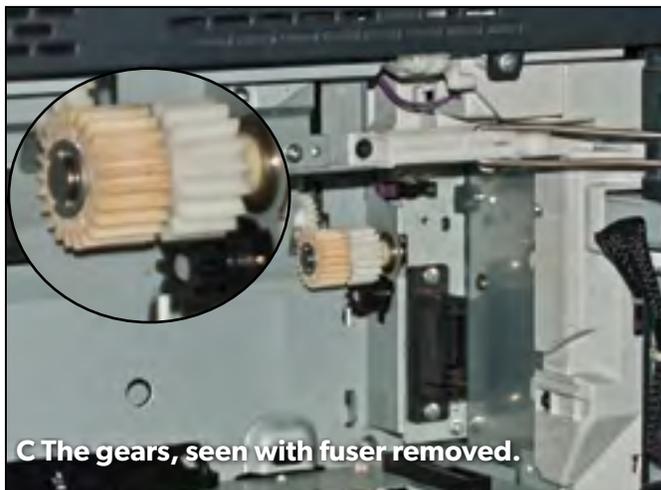
C The gears, seen with fuser removed.

2. REMOVE GEARS FROM PRINTER. You can see the two gears of the one-way gear assembly on the right side of the cavity (Fig. C). Remove the e-ring from the end of the shaft, and slide the gears off. **NOTE: Be very careful when removing and installing e-rings. If one falls into the printer, not only is it lost, but it may also jam up a mechanical assembly or short out an electrical assembly. We recommend spreading a cloth or paper below the e-ring while removing and installing it.**
